## Request For Purchase 8-7-24

### Oneida County B&G

Oneida County Office Building

Replace leaking Butterfly Valves and connections for 5" HWR & HWS  
on a qty of three 2014 Unilux - watertube boilers at the County Office Building.

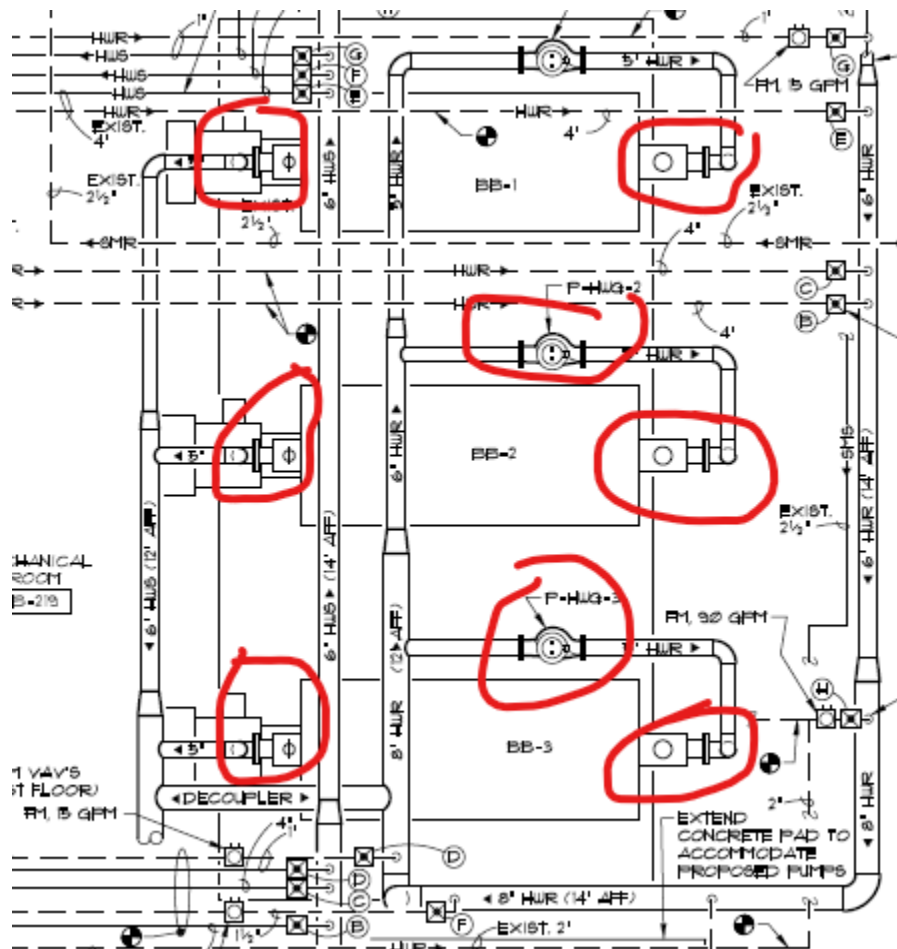
**Leaking 6" connection** (Rev 2 added pictures)

Repair leaking 6" connection above boilers. (See picture) \* Rev 2

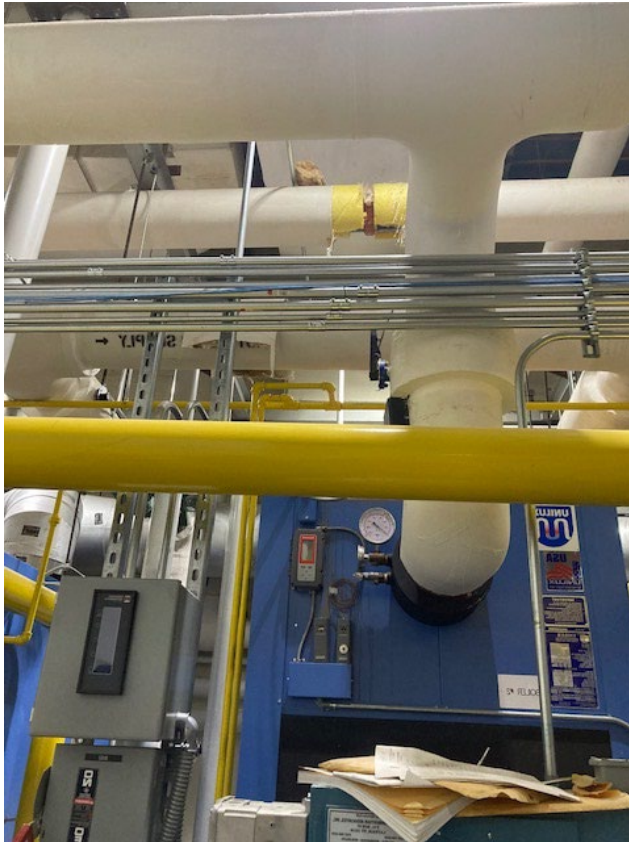
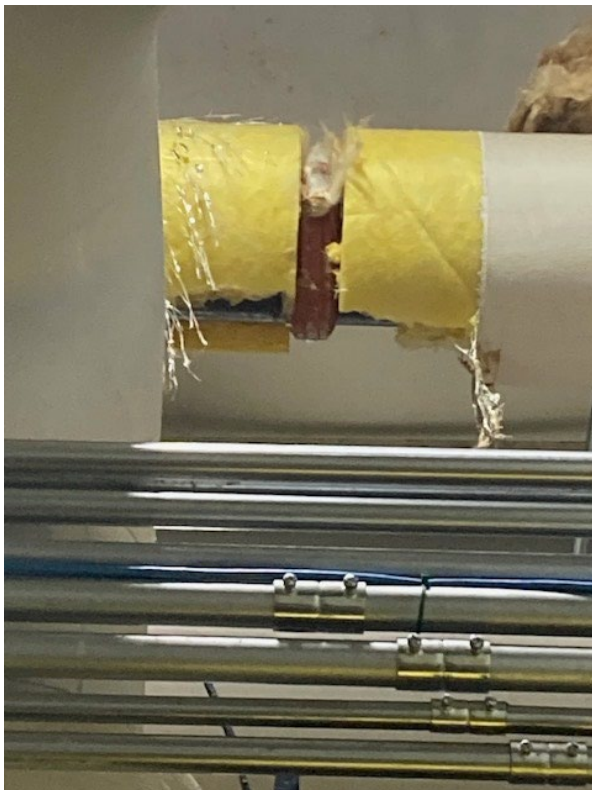
**Rear flanges to be replaced**

Replace rusted flanges and gaskets on rear flange connections. \* Rev 2

Replace rusted flanges and gaskets on rear flange connections.

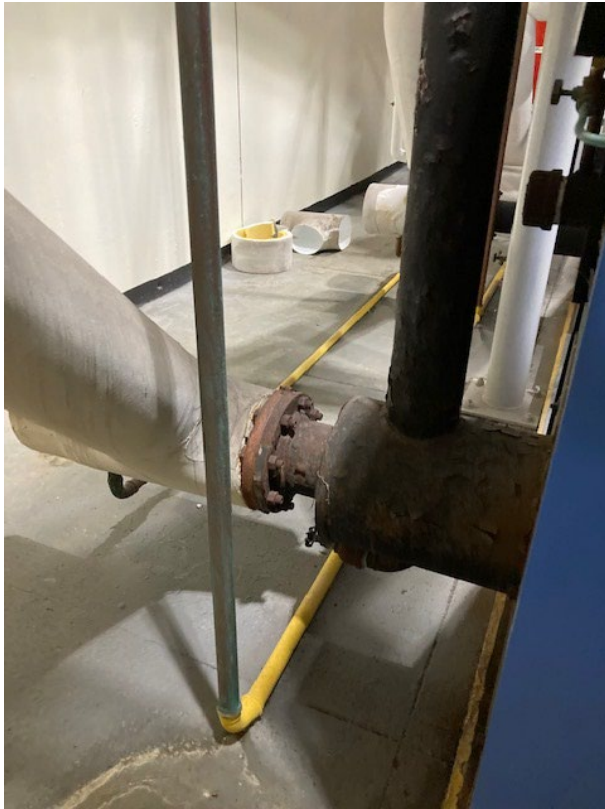
**Butterfly valve near circulation pump to be replaced:**

All Boilers: Replace butterfly valves near boiler circulation pumps. (qty 3)

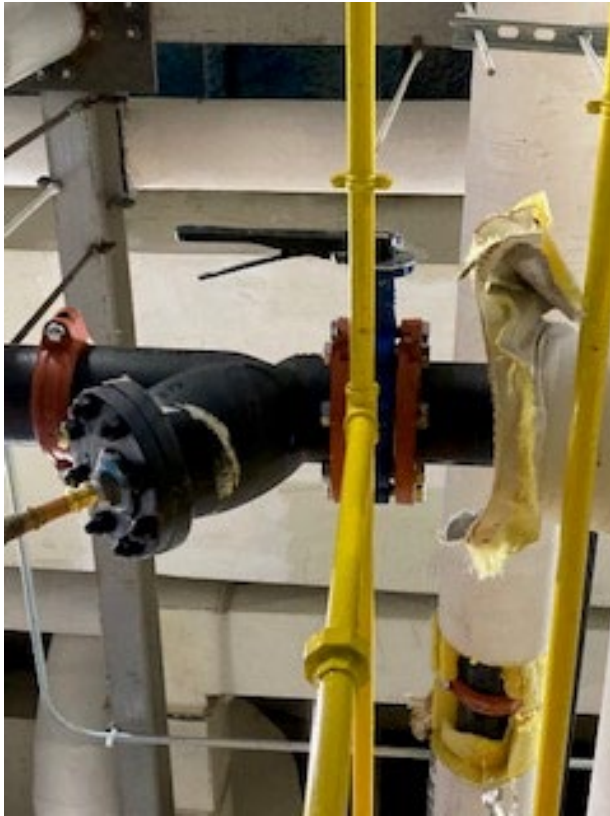
**Front Flange to replace gaskets:**

**Boiler #2 & #3:** Repair leaking connections. Replace gaskets on Front flange connections.

**Boiler #1 :** Repair leaking connections. Replace gaskets on Front flange connections.

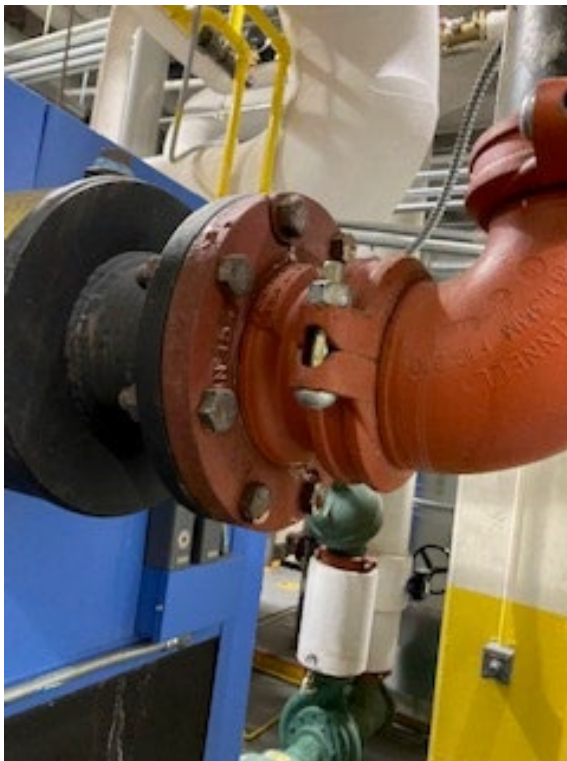
**Circulation pump motor flanges to replace gaskets:**

Replace two butterfly valves that turn the water off for each connection. Repair leaking  
Connections to circulation pumps.

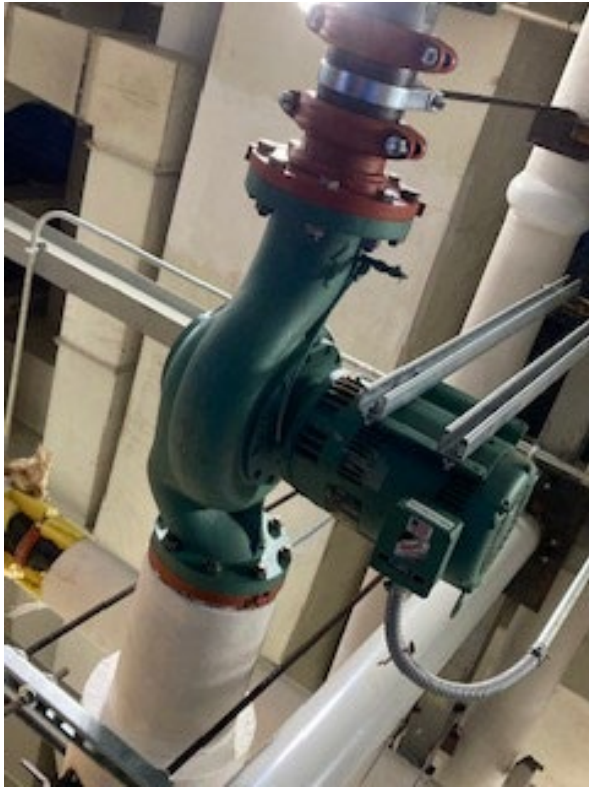
**Front Butterfly valve and Flange**

Replace Butterfly shut off valves with Victaulic brand butterfly valves.

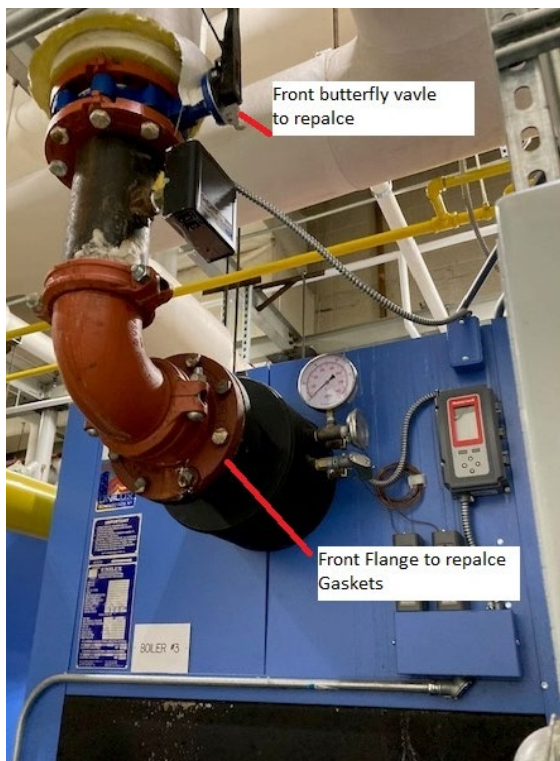
**Rear Butterfly Valves to Replace:**

Replace two butterfly valves that turn the water off for each connection.
